**STANDARD INSTRUMENT DEPARTURES (SID)
BROOME CAT H DEPARTURE (RNAV) RWY 10 & 28
BROOME/INTL, WA (YBRM)**

16 JUN 2022

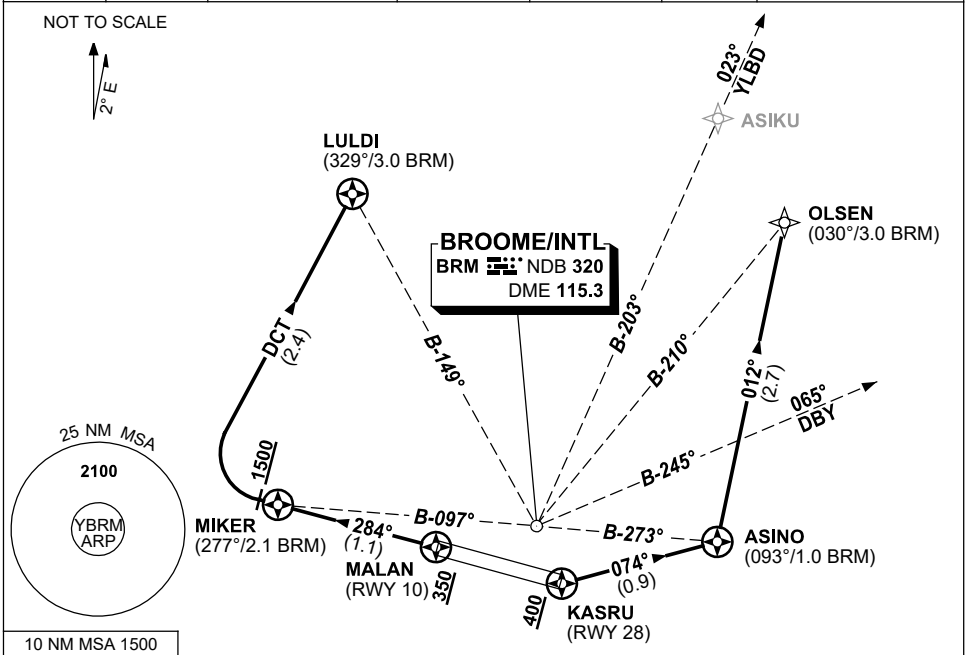
**LULDI ONE (RNAV) DEPARTURE
CAT H ONLY GRAD 5.0%**

- FATO RWY 28 at intersection TWY G
- Proceed visually to MALAN
- Initial Departure Fix MALAN
 Cross MALAN AT or ABV 350ft
- Track 284° to MIKER
- AT or ABV 1500ft, but not before MIKER turn RIGHT
- Track DCT to LULDI (approx. 015°)
- After passing LULDI, track to intercept ATC cleared route by 5 DME

**ASINO ONE (RNAV) DEPARTURE
CAT H ONLY GRAD 5.0%**

- FATO RWY 10 at intersection TWY F2
- Proceed visually to KASRU
- Initial Departure Fix KASRU
 Cross KASRU AT or ABV 400ft
- Turn LEFT, track 074° to ASINO
- Track to intercept ATC cleared route by 5 DME

- Turn LEFT, track 012° to OLSEN
- Track to intercept ATC cleared route by 5 DME
