STANDARD INSTRUMENT DEPARTURES (SID) ESSENDON EIGHT DEPARTURE (RADAR) **MELBOURNE/ESSENDON, VIC (YMEN)**

5 SEP 2024

ESSENDON EIGHT DEPARTURE (RADAR)

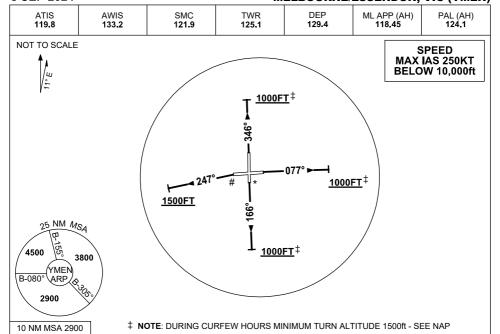
RWY 08

- GRAD 3.3%
- Track 077°
- At 1000ft ‡BUT NOT BEFORE DER turn to assigned heading or track

RWY 26

- GRAD 3.3%
- Track 247°
- At 1500ft BUT NOT BEFORE DER turn to assigned heading

RWY 17

- GRAD 3.6% to 1600ft then 3.3%
- Track 166°
- At 1000ft‡BUT NOT BEFORE DER turn to assigned heading or track

RWY 35

- GRAD 3.3%
- Track 346°
- At 1000ft ‡BUT NOT BEFORE DER turn to assigned heading or track

#CAUTION: FREEWAY AND TRAM SIGNAGE AND LIGHTING UP TO 290ft IN DEP AREA.

*CAUTION: TREES IN RWY 17 DFP ARFA
